Spillways protection

Resistance to Hydraulic Abrasion

Spillways protection with Ciment Fondu®/Alag® concrete was specified for the protection of the AREQUIPA Dam

PERU - 1994

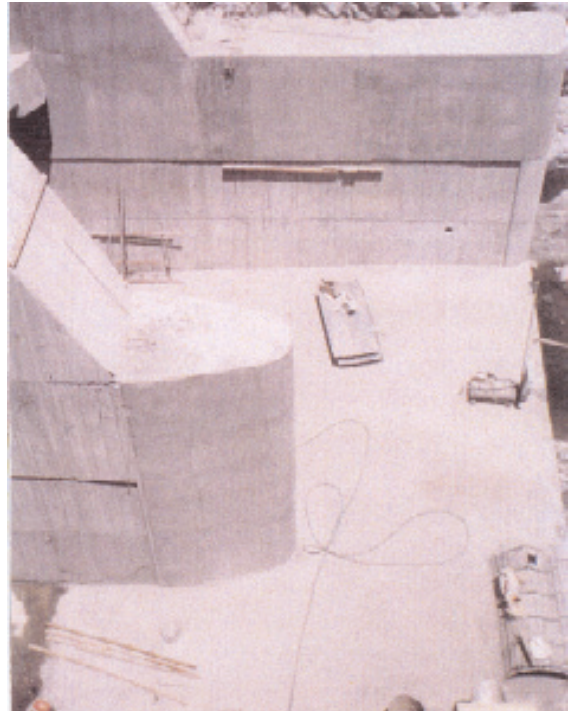
The spillways protection is secured by a Ciment Fondu®/Alag® concrete that resists the effects of hydraulic abrasion and shock from the Rio Chili.

The area of 400 m² was cast using a checker-board method with 2 m squares in average, at a thickness of 20 cm.

Side walls were also protected with a 15 cm thick Ciment Fondu®/Alag® concrete layer.

Wire mesh was fixed in the Portland concrete sub-base to provide a maximum adherence. Ciment Fondu®/Alag® concrete was cast, vibrated and cured following best practices of conventional concrete.
